**CHAPMAN LAKES ENGINEERING
FEASIBILITY STUDY**

KOSCIUSKO COUNTY, INDIANA

February 27, 2003

J.F. New & Associates, Inc.
c/o John B. Richardson
708 Roosevelt Road
Walkerton, Indiana 46574
(574) 586-3400

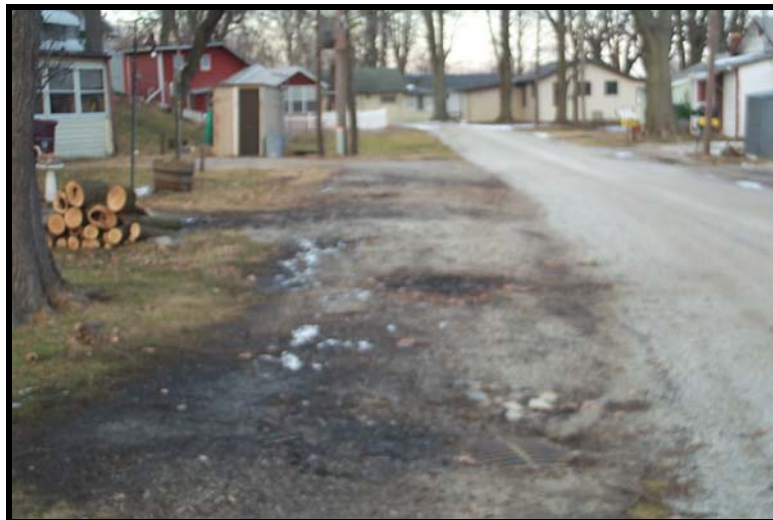
FIGURE 13. Grated inlet for Drain 1.

Located at the northwest side of Chapman Lake on the loop off Gunter Road (EMS 27A and 27B), Drain 1 lies at the southern end of Gunter Road at the bottom of the hill. The inlet has a 16-inch round grated covering (Figure 13). The drain's inlet is about 60 feet from the lake. A 6-inch plastic pipe routs water from the inlet to the east under the road and presumably into Drain 2. The inlet for Drain 2 is located on the northeast corner of the Gunter Road loop. It also has a 16-inch round grated covering (Figure 14). Drain 2 accepts water from the south and east (Drain 1) and from an 8-inch pipe coming from the west. From Drain 2's inlet, the water drains via a 6-inch pipe east-northeast across approximately 150 feet of private open ground before discharging into a wetland and creek (Figure 15).

Drains 1 and 2 deliver an unknown load of sediments, salt, hydrocarbons, and other pollutants from the roadway and adjacent residential property to Chapman Lake without any treatment. Paint was observed on the inlet grate to Drain 2 during a site inspection. The options for treating the stormwater in this neighborhood include: 1) installing swirl collectors; 2) eliminating the drains and regrading the road to allow water to drain to shallow treatment swales or infiltration trenches; 3) constructing a treatment swale at the same elevation as the existing drain pipes; 4) replacing current drain piping with perforated infiltration pipes; 5) scheduling maintenance of the existing catch basins on the drain inlets; 6) educating area residents regarding the drainage system and effects of discharging pollutants to these drains.

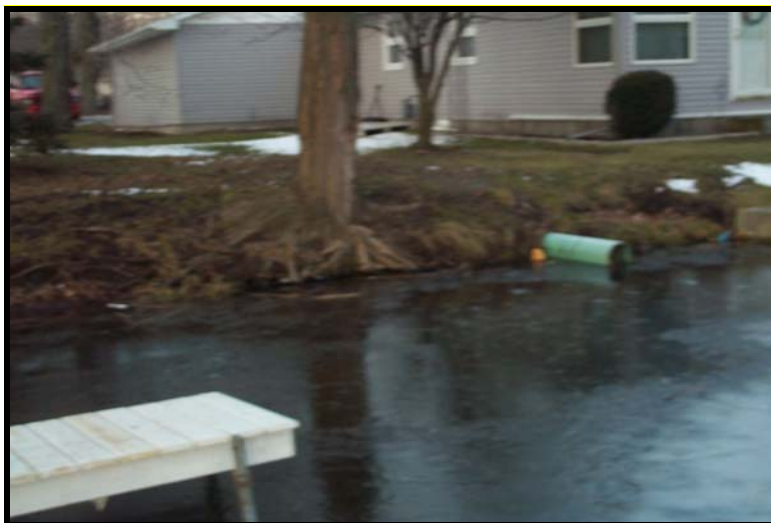
FIGURE 16. Outlet pipe for Drain 3 at Chapman Lake.

Drain 3 is located on northwest side of Big Chapman Lake off County Road 250 East. The drain has an inlet on the north side of EMS 28C Lane and empties to a lake channel through a 10-inch plastic pipe (Figure 16). The pipe passes between two private residences, just to the east of the house on the corner of County Road 250 East and EMS 28C Lane. The discharge of raw sewage from this pipe into the lake was observed during several site visits. A septic system treating wastewater from one of the adjacent residences may be directly tiled into Drain 3. There are two potential solutions to treat the problem noted at this site: 1) persistence in reporting violations to the Health Department; 2) offering the residents money to rebuild the section of pipe and repair the leach field.

The County Health Department was called on several occasions to address this issue. They have so far failed to publicly respond. JFNew recommends contacting the owner and establishing a fund to repair the system.

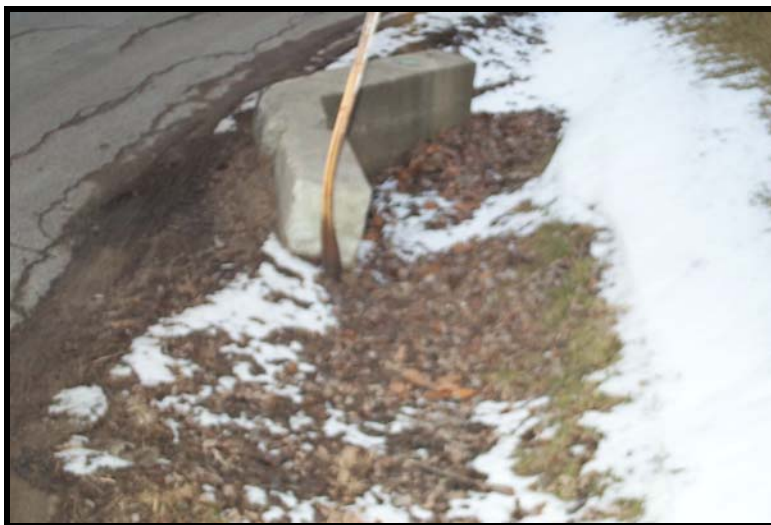
FIGURE 17. Main inlet to Drain 4.

The main inlet to Drain 4 is located by Nellies Bay on the northeast corner of Chapman Lake Drive at its junction with County Road 400 North (Figure 17). A collapsing concrete headwall marks Drain 4's inlet on the inside corner of the road. A 12-inch clay tile directs water under the road and southward about 80 feet toward the lake. The second inlet to the drain is adjacent to the private driveway on the south side of the road with a grate covering the opening that is level with the yard. JFNew and others who have visited the site could not locate the outlet of this drain at the lake. This drain likely delivers small amounts of hydrocarbons, salt, and organic debris to the lake because the outlet is probably partially or fully blocked by previous seawall work. Leaves plugged Drain 4's inlet during the last inspection in the fall of 2002. The alternatives available to treat the stormwater issues at this site include: 1) doing nothing because there does not appear to be a sediment accumulation problem in the lake in this area and there have been no complaints; 2) installing a new headwall/catch basin structure and scheduling regular

maintenance cleaning; 3) rebuilding the roadside swales and installing gravel/sand infiltration trenches to filter water before it reaches Drain 4.

JFNew recommends doing nothing at this time, as there are drains with more significant issues that need to be resolved. When Chapman Lake Drive is scheduled for repaving, it is suggested that this drainage system be reconstructed to include infiltration swales and an inlet catch basin that can be cleaned.

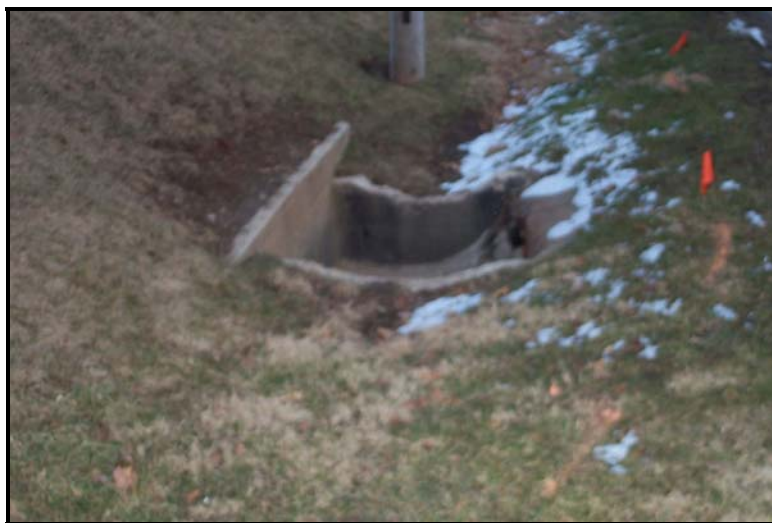
FIGURE 19. Inlet structure for Drain 6.

Drain 6 is a roadside drain located on the east side of Chapman Lake Drive approximately 400 feet south of County Road 400 North intersection. Drain 6 receives water from approximately 400 feet of Chapman Lake Drive. A 4-foot square concrete box structure surrounds Drain 6's inlet (Figure 19). Water entering the inlet structure is directed into a 24-inch metal culvert pipe. The pipe traverses residential land, carrying water about 150 feet directly to Chapman Lake. The drain carries an unknown amount of road salt, sediment, and hydrocarbons to the lake. The alternatives to treat stormwater in this drain include: 1) doing nothing; 2) installing a deeper catch basin structure that would trap sediment and debris and scheduling regular maintenance cleaning; 3) rebuilding the delivery swales to include gravel/sand infiltration trenches. JFNew recommends that the inlet structure be rebuilt with a functioning catch basin and pretreatment infiltration swales be installed when the county repaves Chapman Lake Drive.

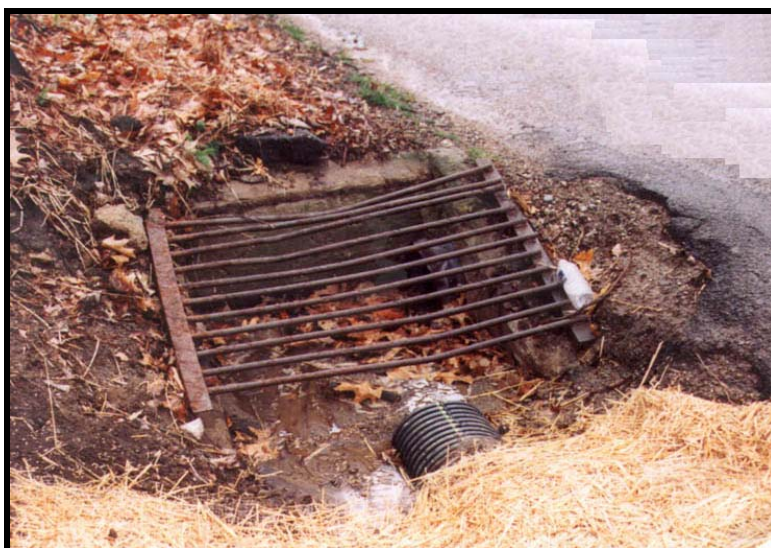
FIGURE 20. Inlet to Drain 7.

The inlet to Drain 7 is located on the east edge of Chapman Lake Drive approximately 500 feet north of Crooked Creek. The drain's inlet consists of a steel grated 3-foot square concrete box structure (Figure 20). A 12-inch metal pipe carries water from the inlet to Chapman Lake. Surface runoff from about 300 feet of Chapman Lake Drive and a series of gravel driveways discharges into Drain 7. Drain 7 conveys a significant load of sediment to the lake as evidenced by the sediment accumulation in Chapman Lake near Drain 7's outlet. The alternatives to treat stormwater at this site include: 1) having property owners in the drainage basin pave their driveways to eliminate sediment originating from gravel drives; 2) installing a larger catch basin structure and scheduling regular maintenance cleaning; 3) installing gravel infiltration trenches in roadside swales; 4) creating a rain garden at the drain's inlet. JFNew recommends a combination of two treatments: creating roadside infiltration trenches and installing a rain garden infiltration system at the inlet.

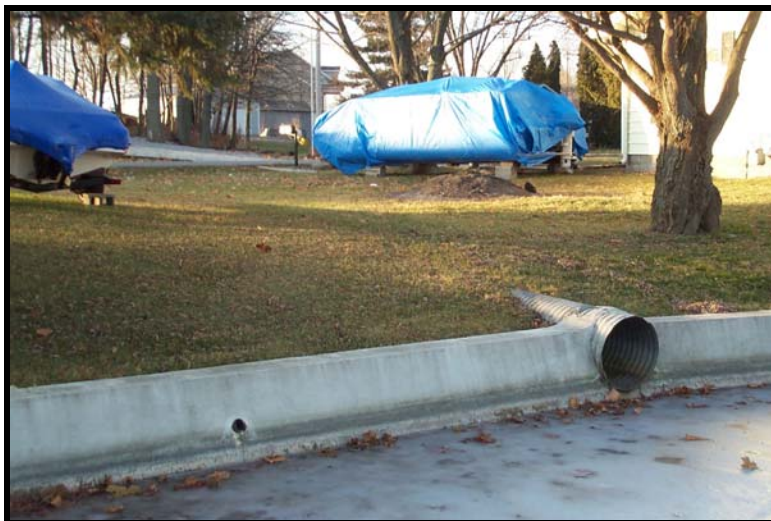
FIGURE 21. Drain 8 outlet at Chapman Lake.

The inlet to Drain 8 is located on the south side of Chapman Lake Drive, 300 feet west of the lake's public boat ramp. An open swale carries surface runoff to Drain 8's inlet. From the drain's inlet, a 24-inch metal pipe conveys water under the road and under open residential property (the neighborhood lake access area). Water from the pipe discharges into Chapman Lake through an opening in a concrete seawall approximately 60 feet from the drain's inlet (Figure 21). The pipe has discharged varying amounts of sediment over the years as evidenced by the sediment accumulation in the channel at the drain's discharge point. The drain also likely contributes road salts and hydrocarbons to the lake. The alternatives considered to treat stormwater at this site include: 1) doing nothing; 2) installing a permanent catch basin and scheduling regular maintenance cleaning; 3) reconstructing the road side swales as infiltration trenches; 4) constructing a small wetland treatment basin in the neighborhood access area to trap nutrients, hydrocarbons, and sediment that may enter the drain from the road. JFNew recommends constructing a small wetland treatment basin that is conceptually designed to treat nutrients, hydrocarbons, and sediment.

Drain 8 empties into a channel off Big Chapman Lake just west of the public boat launch (Figure 21; Figure 26). JFNew recommends the installation of a small treatment wetland on the 75-foot

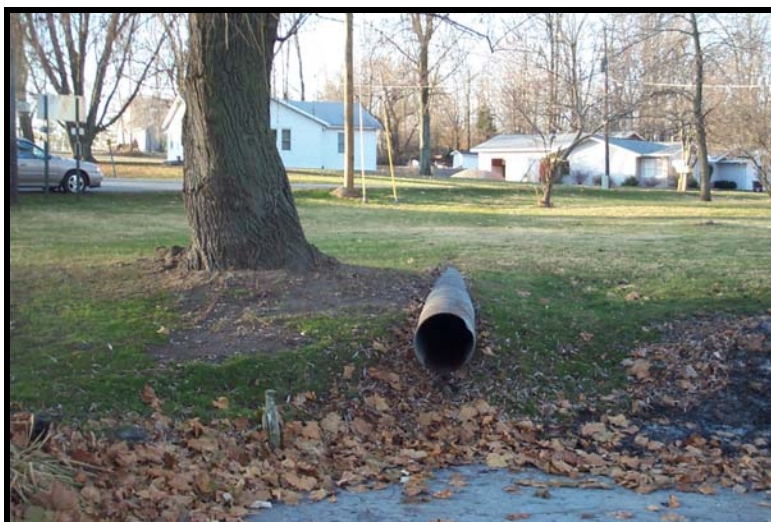
FIGURE 22. Drain 9 outlet at Chapman Lake.

Drain 9's inlet is located on the southwest corner of the intersection of County Road 325 East and Chapman Lake Drive. The natural earthen inlet area drains into an 18-inch culvert that carries water diagonally across the intersection approximately 75 feet to the lake (Figure 22). The path of the drain crosses under the road onto private property for about 30 feet before entering a neighborhood easement to a channel. The pipe discharges into the channel on the easement. The pipe has discharged varying amounts of sediment over the years as evidenced by the sediment accumulation the lake's channel at the discharge point. The drain also likely contributes road salts and hydrocarbons to the lake from the road. The alternatives considered to treat stormwater at this site include: 1) doing nothing; 2) installing a permanent catch basin and scheduling regular maintenance cleaning; 3) reconstructing the roadside swales as infiltration trenches; 4) constructing a small wetland treatment basin in the neighborhood access area to trap nutrients, hydrocarbons, and sediment that may enter the drain from the road. JFNew recommends constructing a small wetland treatment basin conceptually designed to treat nutrients, hydrocarbons, and sediment.

Drain 9 empties into a channel off Big Chapman Lake at the intersection of County Road 325 East and Chapman Lake Drive (Figure 22; Figure 28). JFNew recommends installing a small treatment wetland on the 75-foot wide access easement near the channel (Figure 29). The treatment wetland as proposed would intercept the existing 18-inch metal pipe approximately 40 feet from the Chapman Lake Drive within the public access easement. A 20-foot diameter pool approximately three feet deep would be excavated at the new outlet of the pipe. The pool would trap sediment, reducing sediment loads to the lake. The next section of proposed treatment would be a shallow swale approximately 30 feet long. The swale would be vegetated with common sedges or rushes to absorb pollutants that passed through the pool. The final step in the treatment would be a gravel or rock chute extending to the water surface in the lake channel. This treatment wetland would remove from 60 to 90% of the solids and associated pollutants from the stormwater entering the lake at this point. Cleaning the existing channel to its original depth and establishing a vegetated buffer at the final outlet of the rock chute could gain additional treatment.
